# **Encapsulation of Methamphetamine-Contaminated Building Materials**

John W. Martyny, Ph.D., CIH  
Associate Professor  
Division of Environmental and Occupational Health Sciences  
National Jewish Health

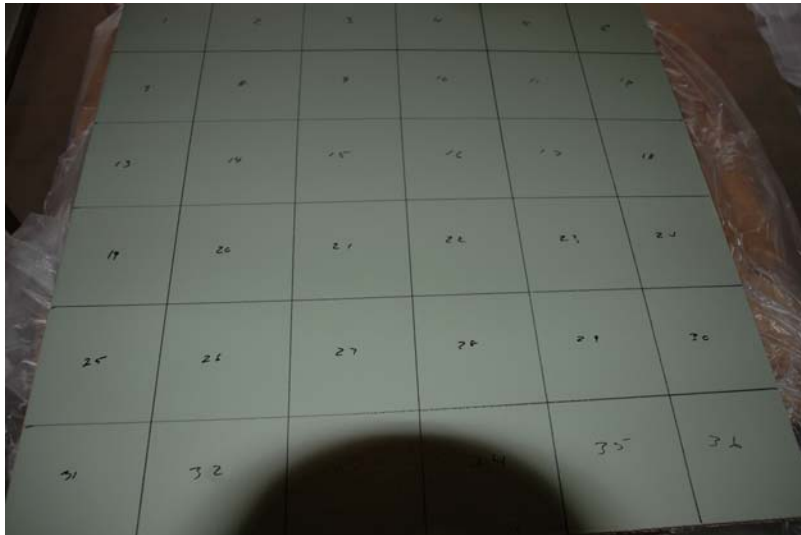
Figure 4. Panel prepared for initial pre-sampling after contamination.

For each panel, there were a total of 36 potential 100 cm<sup>2</sup> samples available. The squares sampled were determined using random number generator for each panel using numbers from 1 – 36. The two groups of 5 samples were generated with no replicates and the position of the samples were located on the panel using the following template:

i.	1	2	3	4	5	6
ii.	7	8	9	10	11	12
iii.	13	14	15	16	17	18
iv.	19	20	21	22	23	24
v.	25	26	27	28	29	30
vi.	31	32	33	34	35	36
